# Xerox Production Systems Fault Code Reference Book IV

## **DT61xx Fault Code Reference Book**

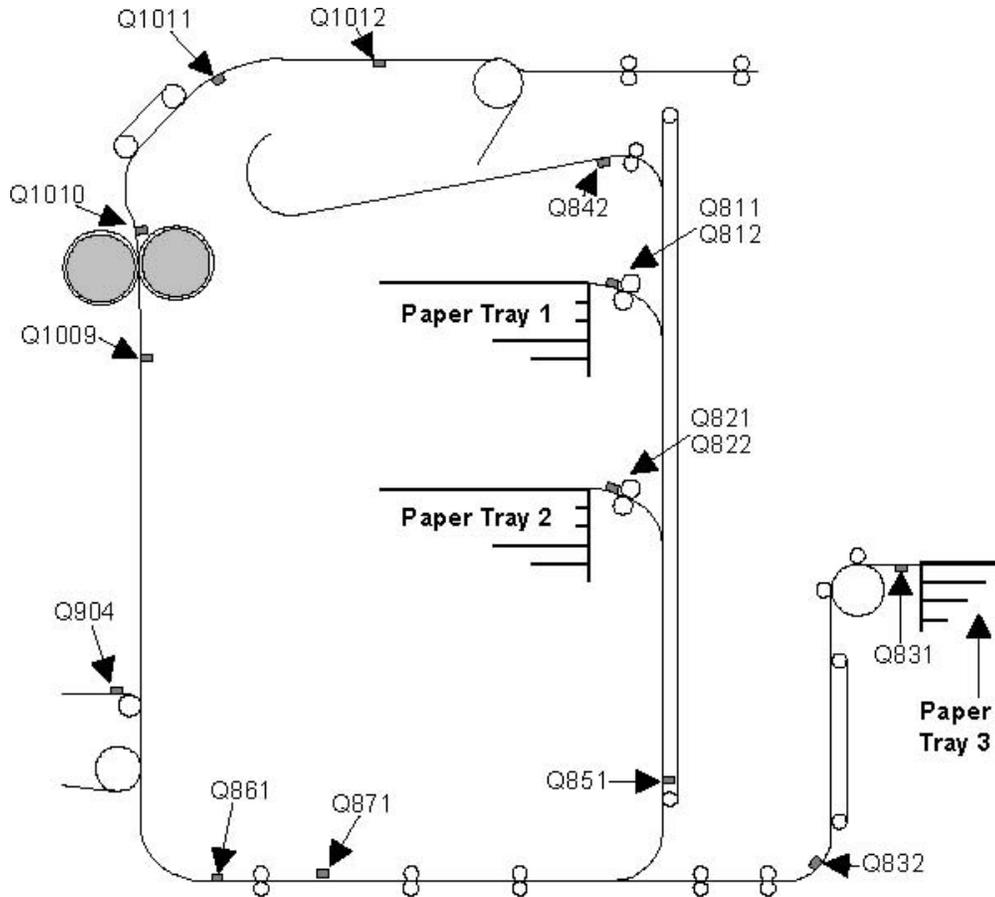
## Paper Handling Module Sensor Locations

- Q811 Tray 1 Take Away Roll Sensor
- Q812 Tray 1 Stack Relief Sensor
- Q821 Tray 2 Take Away Roll Sensor
- Q822 Tray 2 Stack Relief Sensor
- Q831 Tray 3 Feed Sensor
- Q832 Tray 3 Transport Sensor
- Q841 Duplex Inverter Position Sensor
- Q842 Duplex Inverter Exit Sensor
- Q851 Vertical Transport Switch
- Q861 Registration Transport Sensor
- Q904 POP Sensor
- Q1009 Prefuser Sensor
- Q1010 Post Fuser Sensor
- Q1011 Decurler Sensor
- Q1012 Top Transport Sensor

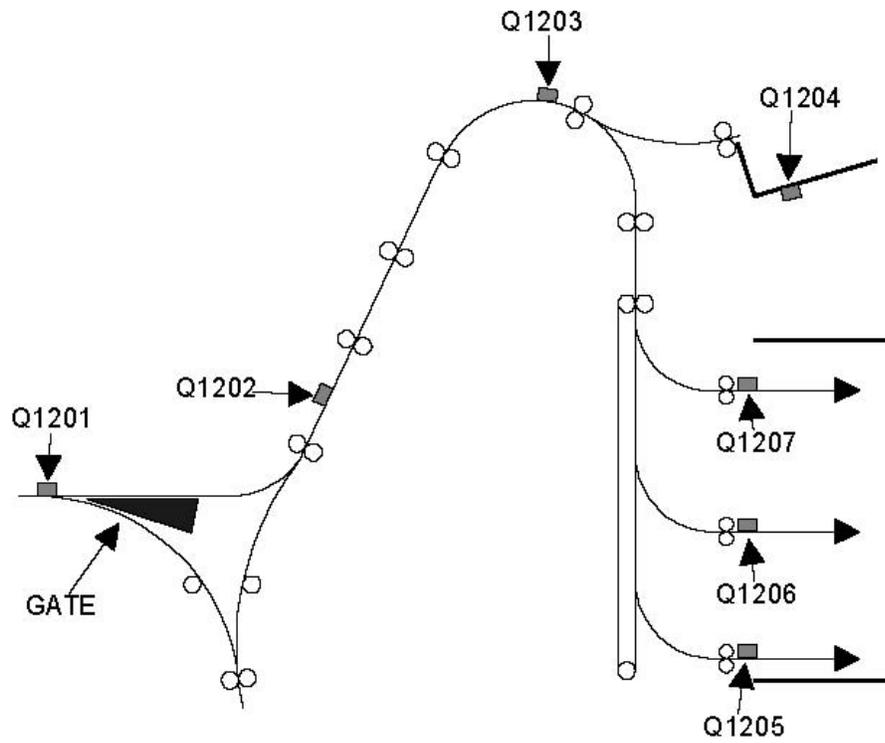
**Inverter Sensor Locations**

- Q1201 Finisher Entrance Sensor*
- Q1202 Post Inverter Sensor*
- Q1203 Top Transport Output Sensor*
- Q1204 Top Tray Empty*
- Q1205 Bin A Entrance Sensor*
- Q1206 Bin B Entrance Sensor*
- Q1207 Bin C Entrance Sensor*
- Q1222 Bins Exit Sensor*

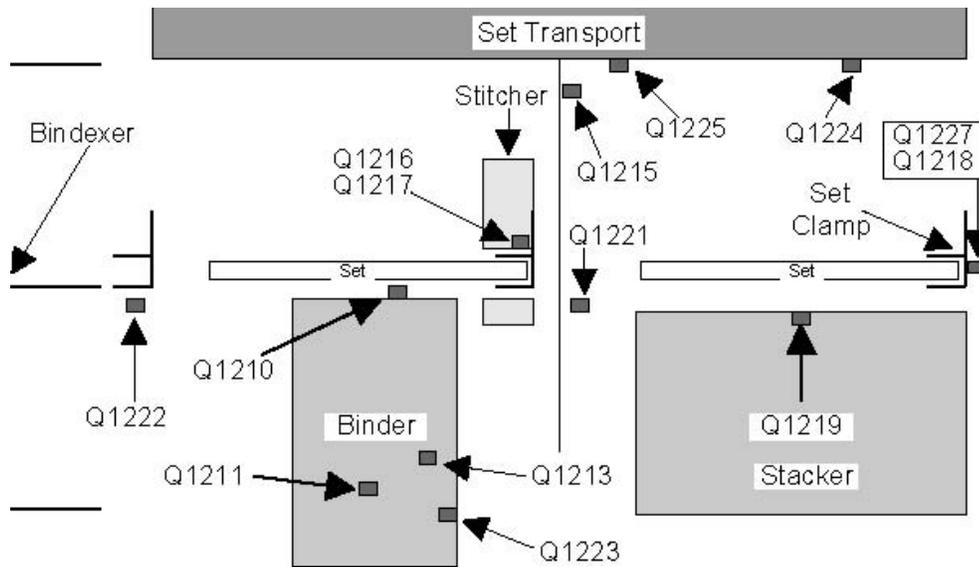
**Finisher Sensor Locations**

- Q1210 Set in Tilt Bed Sensor
- Q1211 Flapper Position Sensor
- Q1213 Tape in Guide Sensor
- Q1215 Stitcher Position Encoder
- Q1216 Catch Wire A Sensor
- Q1217 Catch Wire B Sensor
- Q1218 Rear Stack Height Sensor
- Q1219 Stacker Drawer Empty Sensor
- Q1221 Set Path Sensor
- Q1222 Bins Exit Sensor
- Q1223 Tape Feeder Sensor
- Q1224 Set Transport Home Sensor
- Q1225 Set Transport Position Sensor
- Q1227 Front Stack Height Sensor

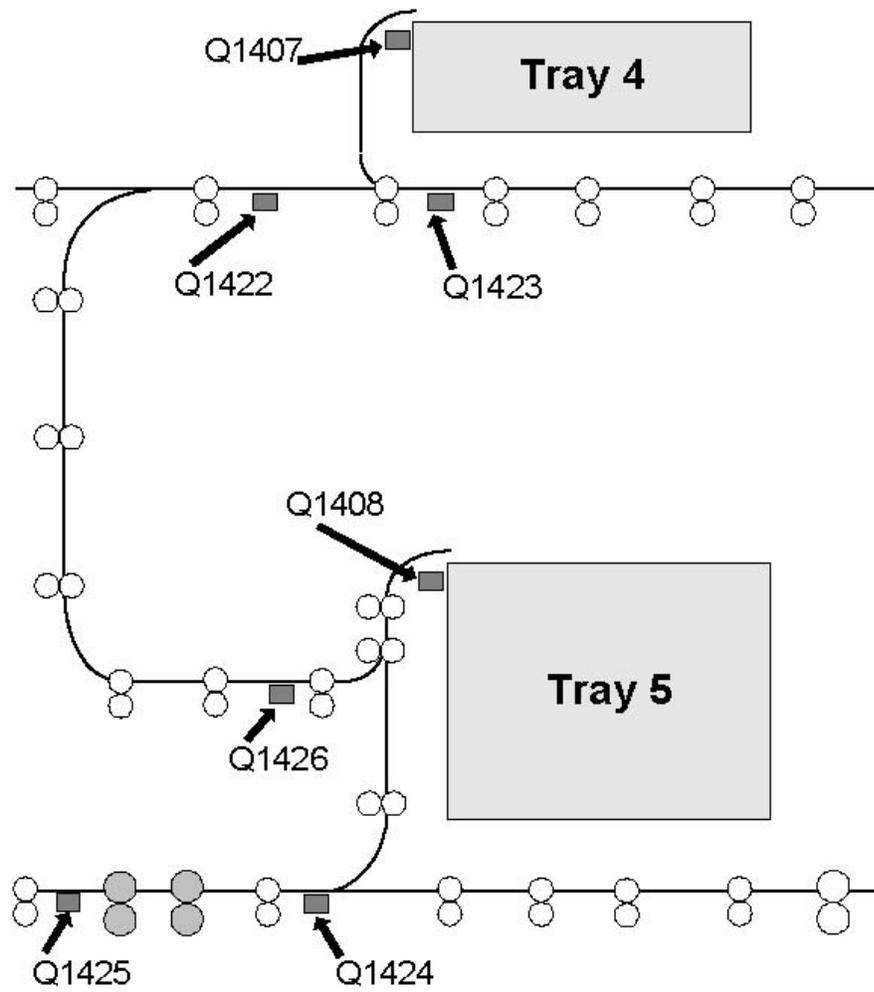
**Interposer Sensor Locations**

- Q1422 Top Transport Entrance Sensor
- Q1423 Top Transport Exit Sensor
- Q1424 Lower Transport Turn Jam Sensor
- Q1425 Lower Transport Exit Jam Sensor
- Q1426 Loop Jam Sensor
